Accessory Drive Tensioner

by Al Steadman, Litens

VW Europe TSB: Accessory Drive Tensioner Ineffective, Broken

Procedure No.: 250901/3

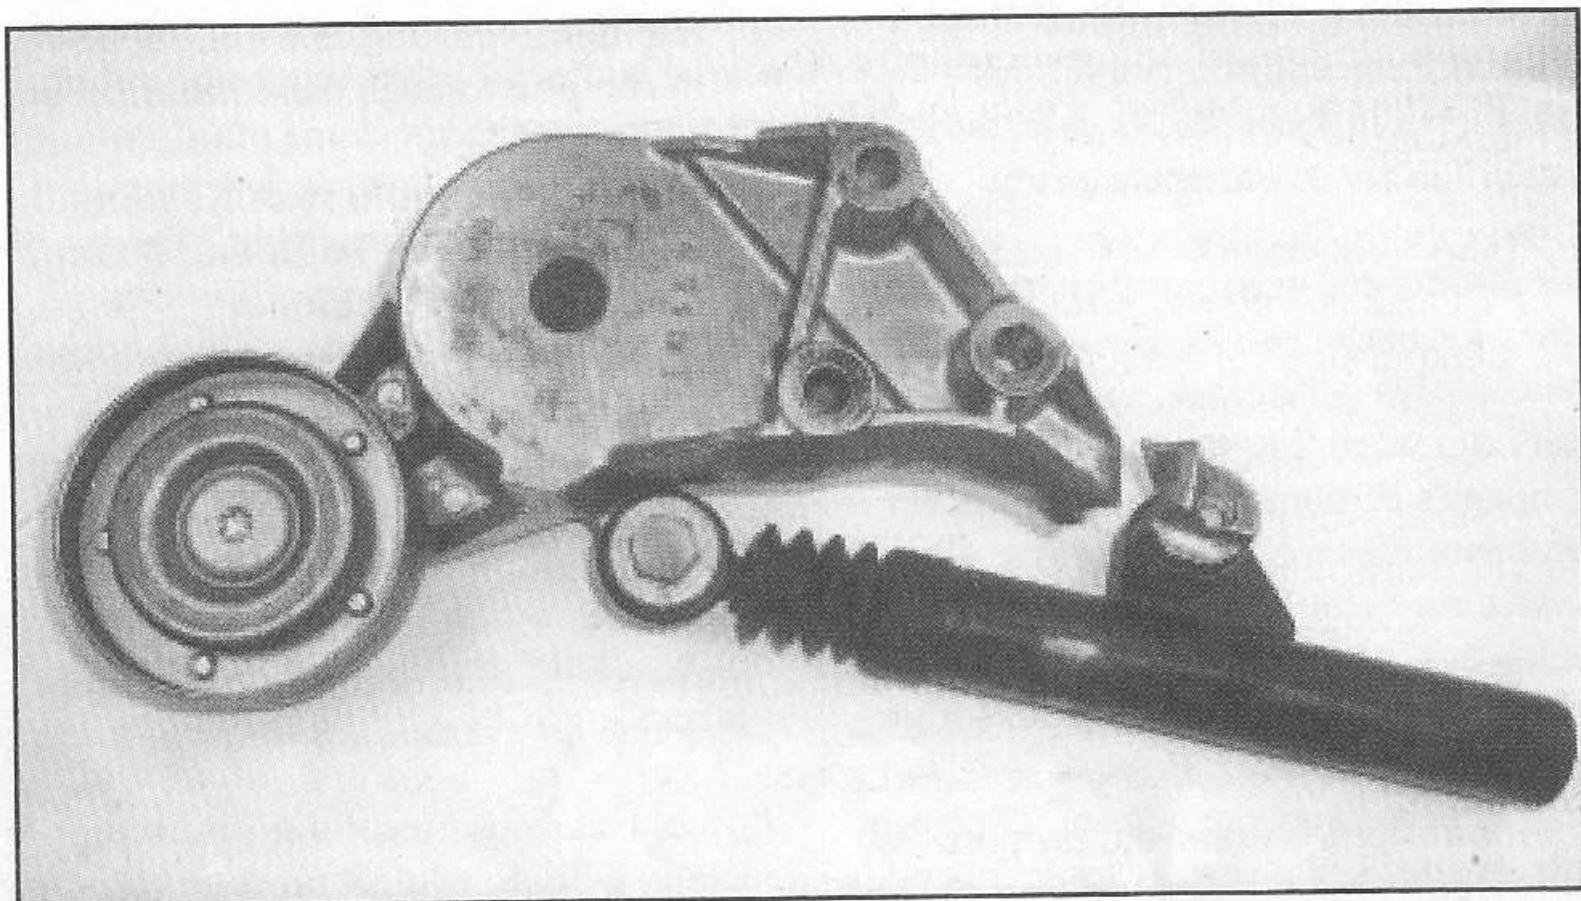
It appears that the worldwide electrical rebuilding industry still has not learned that cutting corners may have serious consequences and end up costing the owner more in the long run. VW Europe has just recently issued a technical service bulletin (see below) regarding the substitution of solid alternator pulleys for one-way clutch pulleys. The swapping in of the cheaper solid pulley in a belt drive system that has been designed with a one-way clutch pulley or Litens IDP may cause the tensioner to break apart.

The tensioner failing is directly related to the increased vibration levels within the belt drive system once the solid pulley is installed. Bottom line is, you should always check the Lester Kwikfinder (www.kwikfinder.net) or your local dealership to see if the alternator you are rebuilding requires a one-way clutch or a Litens IDP. Use only what the manufacturer has designed for the system.
